TS-PIC- 90783/91783
November 1990

AERIAL PHOTOGRAPHIC ANALYSIS OF SHELL CHEMICAL - DEER PARK MANUFACTURING COMPLEX

Deer Park, Texas

EPA Region 6

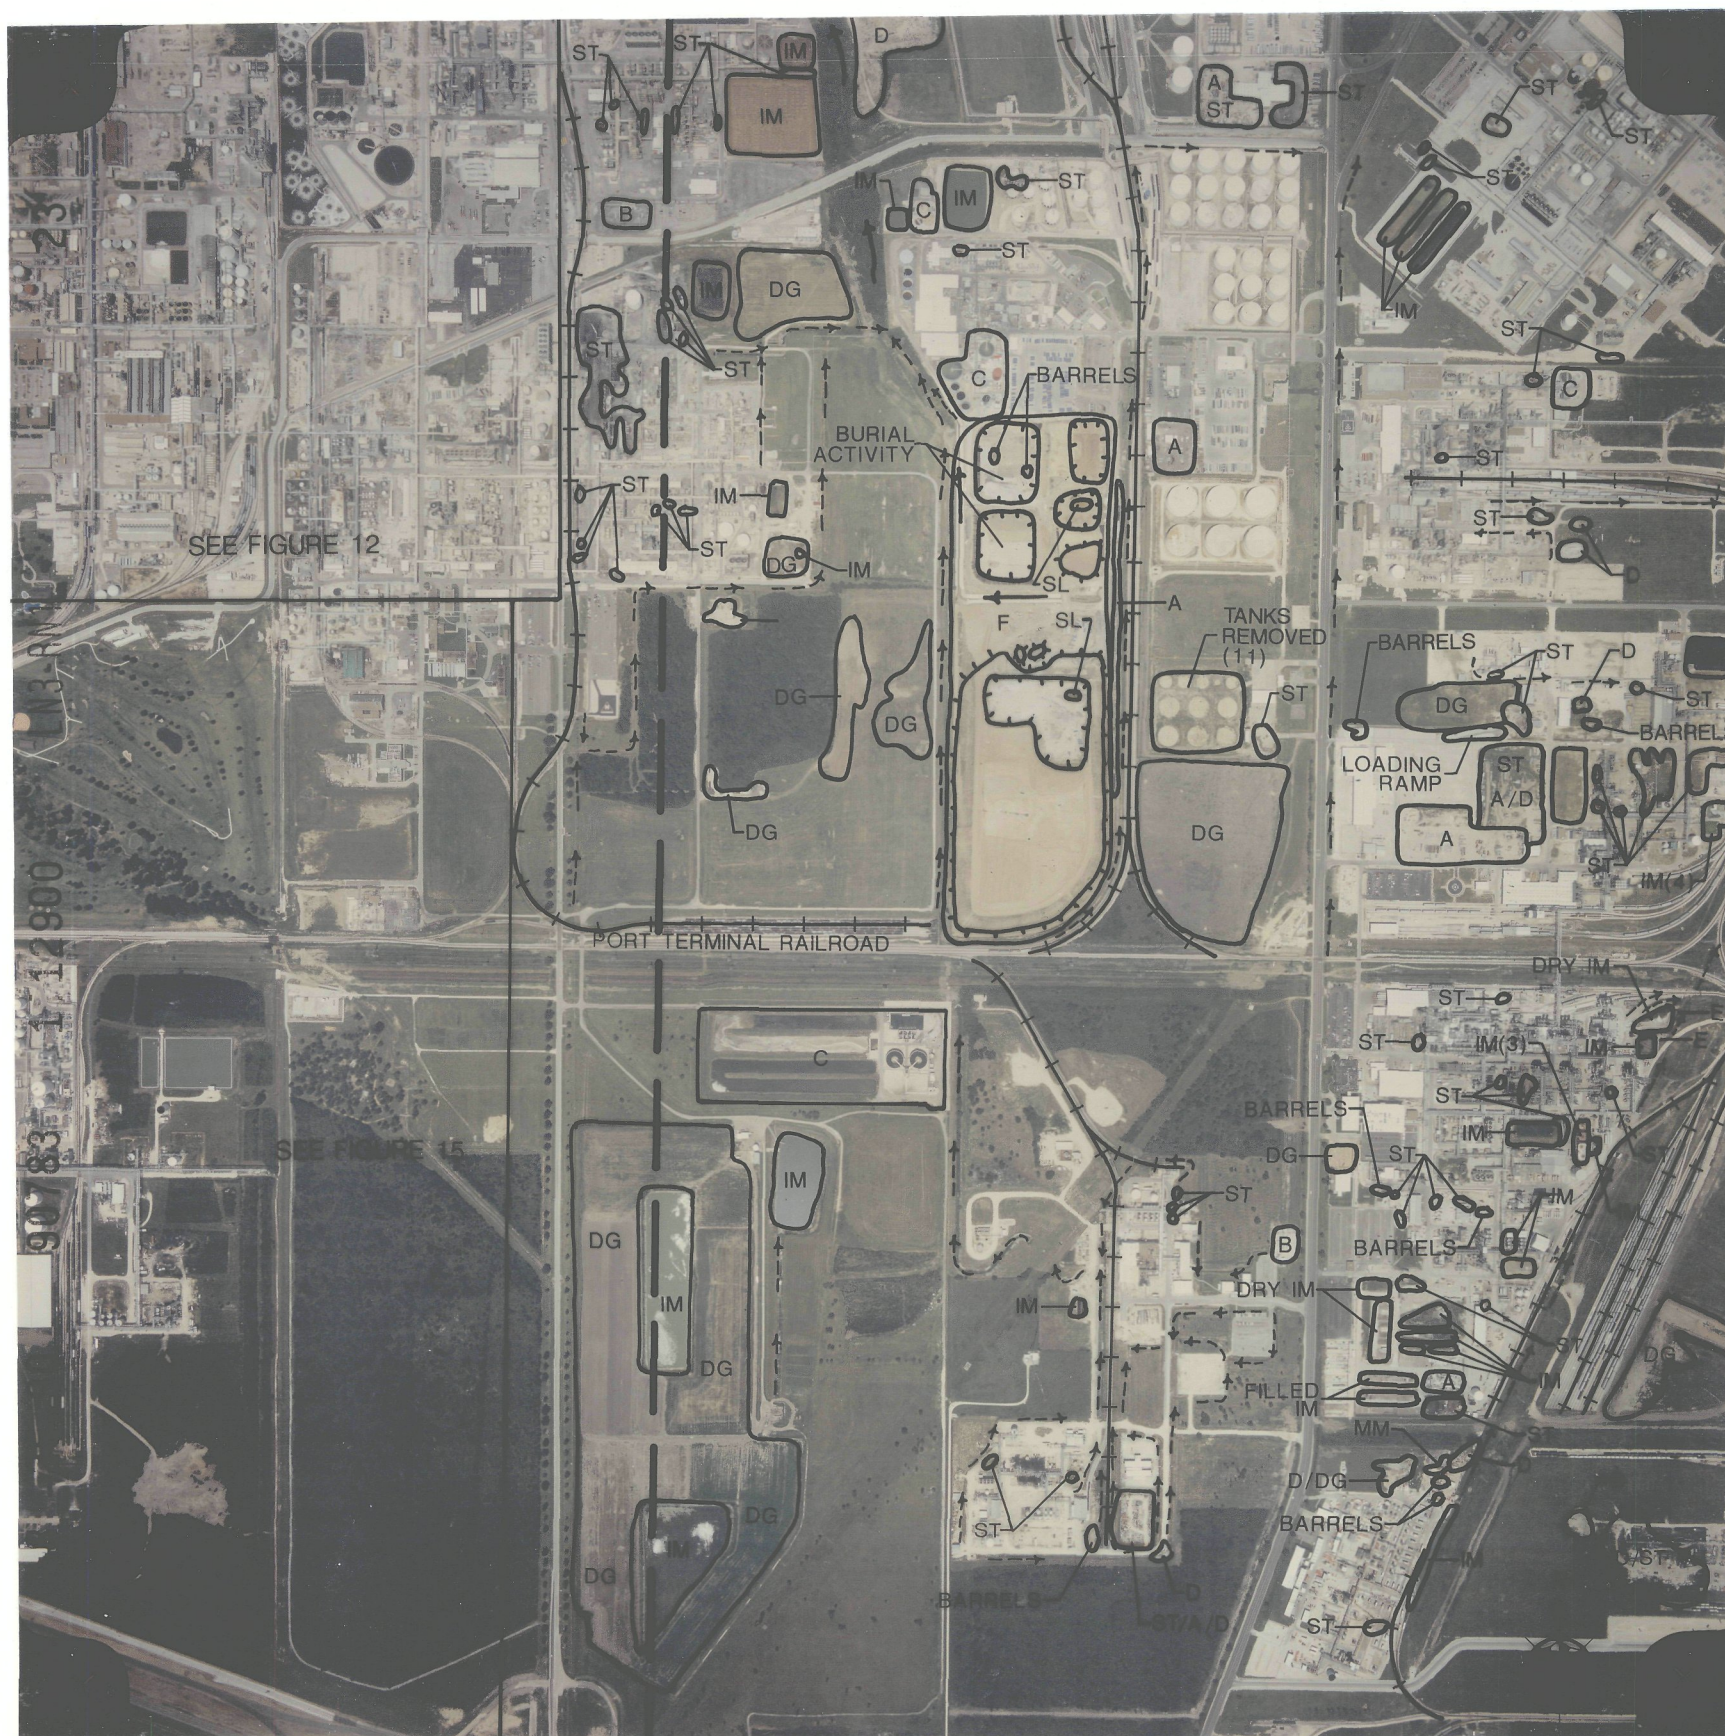
Figure 16. Shell Chemical-Deer Park Manufacturing Complex, August 26, 1990.  
Approximate scale 1:12,900.

This photo covers areas that were previously discussed on Figures 5, 6, 9, and 10. All the tanks in this photo are adequately contained. Staining is visible in many areas. Eleven tanks were removed, leaving ground scars where the tanks were. The mounded material that is located in the waste disposal area is associated with burial activity in the site. Barrels are visible in the northern pit in the waste disposal area. This pit is actively disposing of waste. The southern pit appears to still be being prepared to receive waste. The large mounded area was in the past used as a burial site and has since been covered over. In the same area were several liquid impoundments but they have also been covered over. There are 29 liquid impoundments and 15 areas of ground disturbances visible. Seven areas are identified that are being used as barrel storage. Other significant features are described below.

| A | These are seven storage areas. |
| B | These are two power substations. |
| C | These are four water treatment facilities. |
| D | These nine areas have been used for dumping. |
| F | This is a waste disposal area and was discussed earlier. |

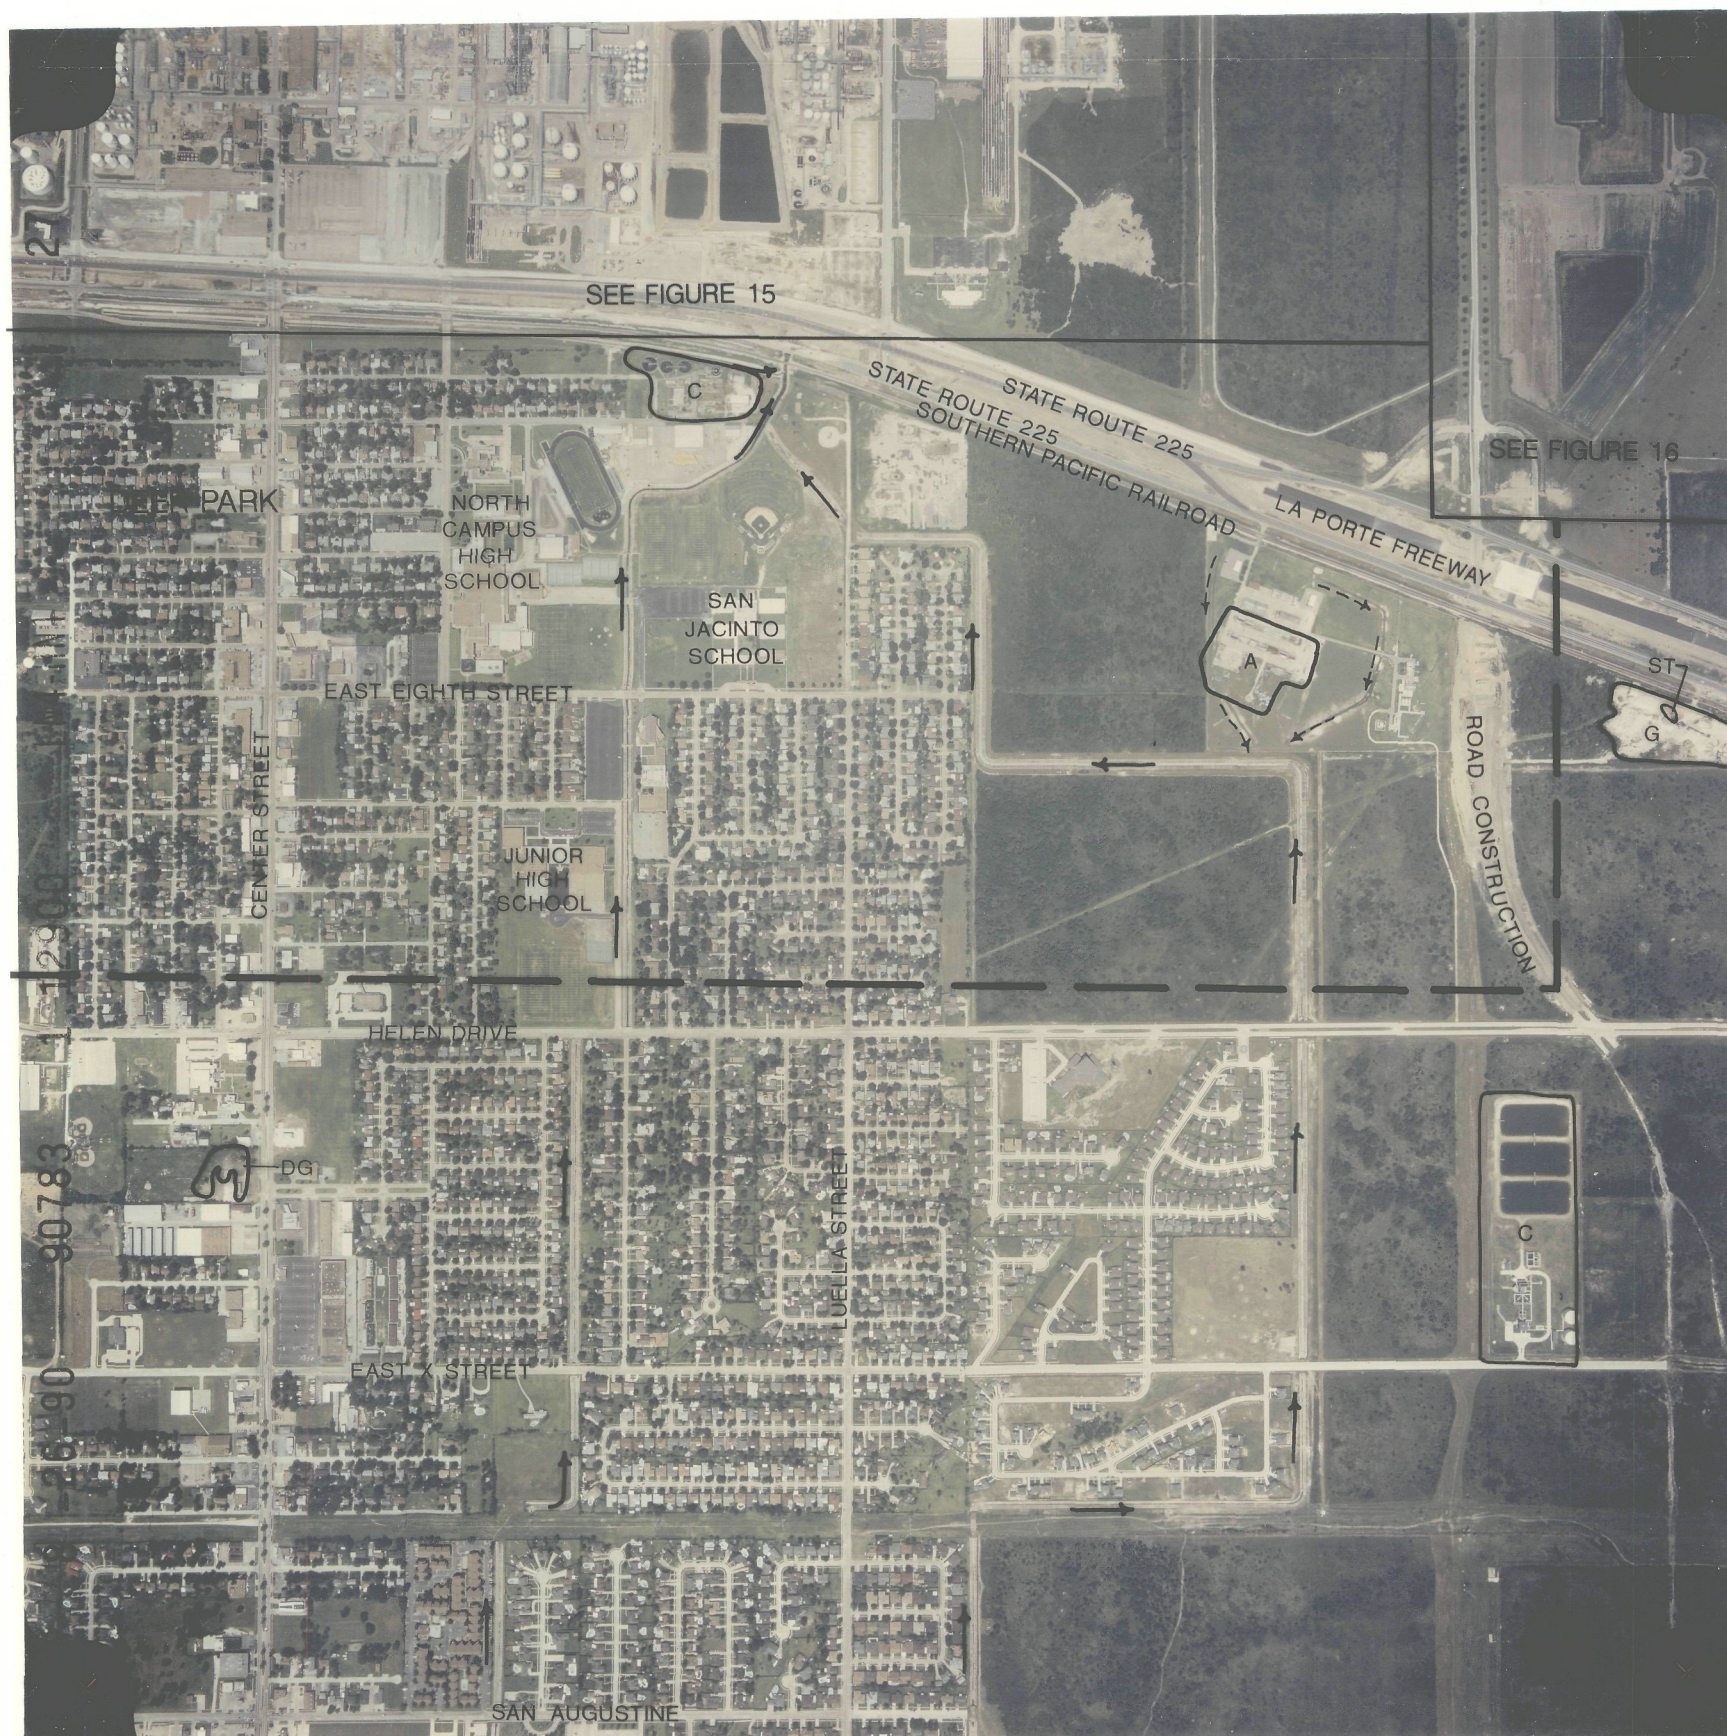
Figure 17. Shell Chemical-Deer Park Manufacturing Complex, August 26, 1990.  
Approximate scale 1:12,900.

This photo covers an area that was previously discussed in Figures 6 and 10. No liquid impoundments were visible but one area of ground disturbance is located on this photo. Staining is visible in the sand and gravel operation. The northern area of Deer Park is shown as are three schools that are within the study area. Other significant features are described below.

Annotation	Description
A	This is a storage area.
C	These are two water treatment facilities.
G	This is a sand and gravel operation with a railcar loading area and is supported by the Southern Pacific Railroad.
